## **Problems with Lead-Free Soldering**

The boards of 6 different companies were tested

### **Reliability testing:**

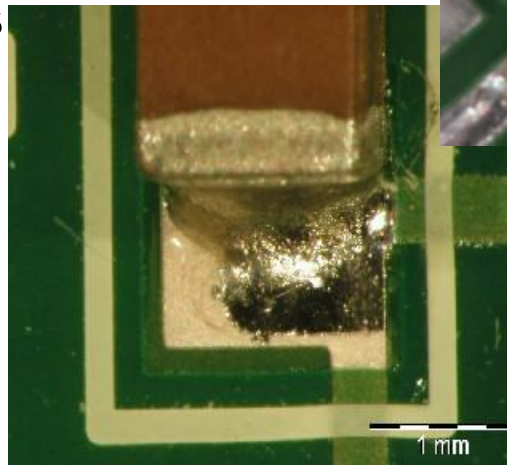
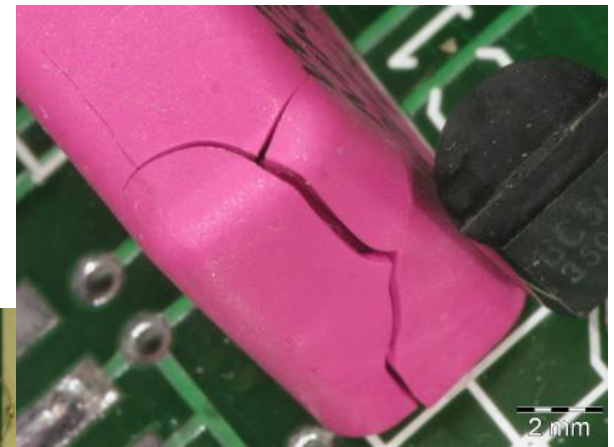
- ☐ Investment in Equipment's
- ☐ Thermal limitations and commercial availability of components and materials
- ☐ Flux compatibility
- ☐ Wettability

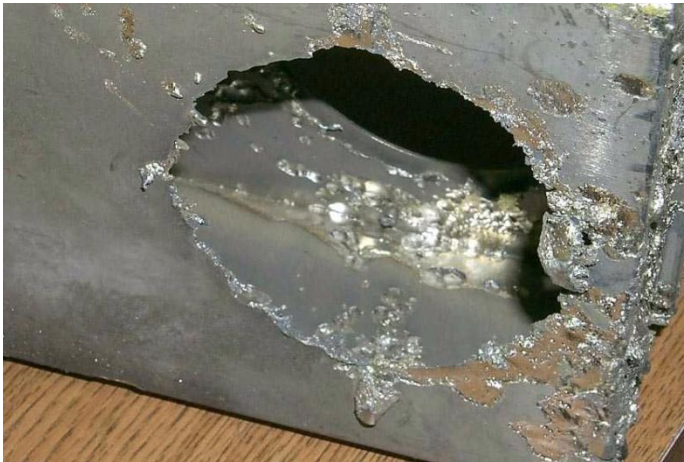
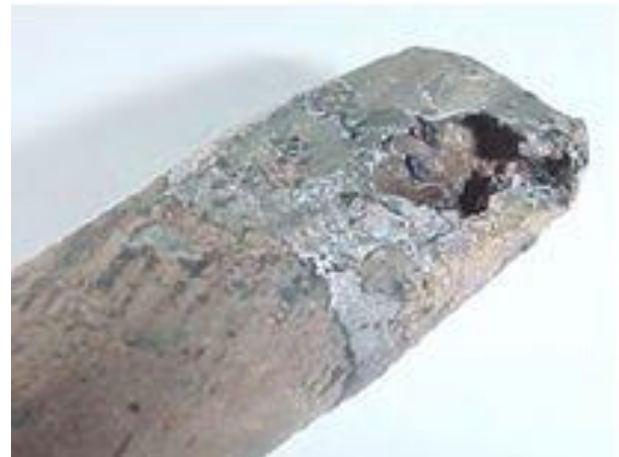
- ☐ Contamination
- ☐ Degradation of the tips of the soldering irons

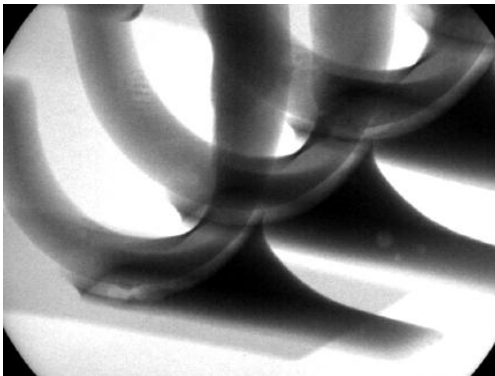
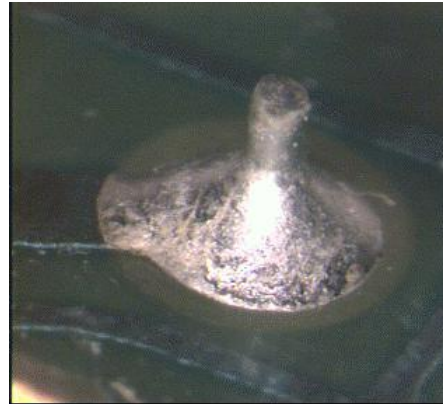
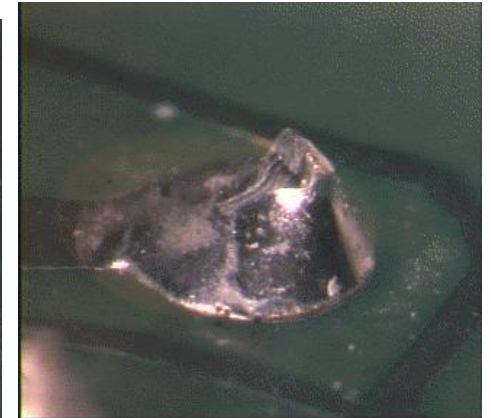
- ☐ Visual aspect of the joints
- ☐ Defects
- ☐ Reliability of the products

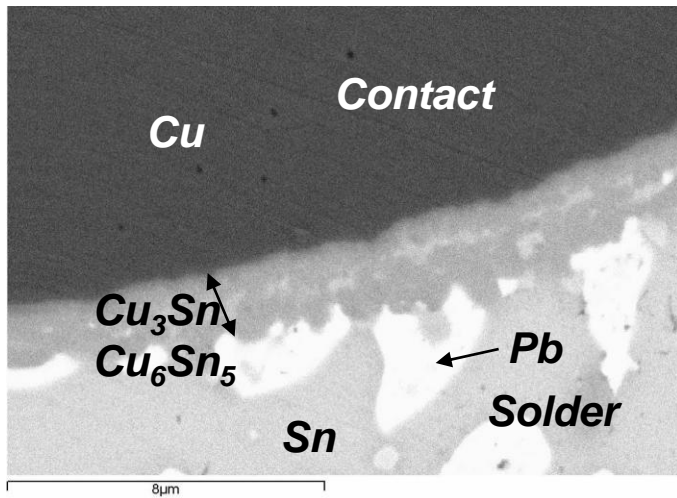
- ❑ Lift of the contact with the board

<i><b>Material</b></i>	<i><b>CET (x10<sup>-6</sup>/K)</b></i>
<i>Sn</i>	<i>23.5</i>
<i>Ag</i>	<i>18.9</i>
<i>Cu</i>	<i>17</i>
<i>Ni</i>	<i>13</i>
<i>Pb</i>	<i>29</i>
<i>Cu<sub>3</sub>Sn</i>	<i>18.4</i>
<i>Cu<sub>6</sub>Sn<sub>5</sub></i>	<i>20</i>
<i>Laminated</i>	<i>17</i>
